Study on the Stability of Large Retrogressive Landslide and Treatment Technology

Guan Jiang^{1,*}, Zhongju Feng², Ruixin Zhao², Yuanmeng Chen¹ & Xiaofei Liu³

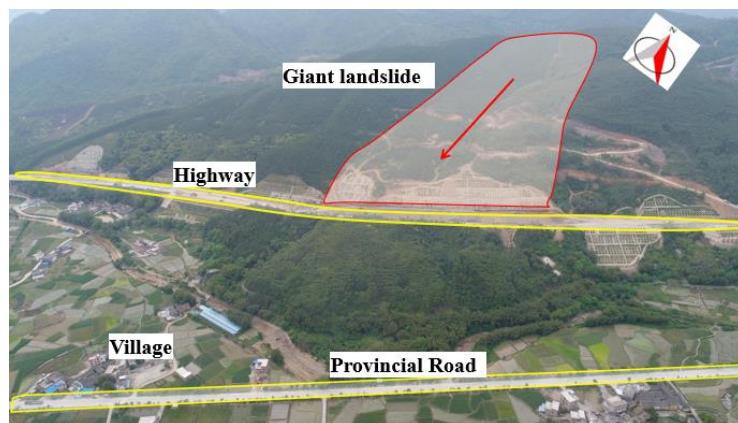
The relative position between the landslide and the highway is shown in Figure 1.

Figure 1 Relative geographical position between the landslide and the highway.

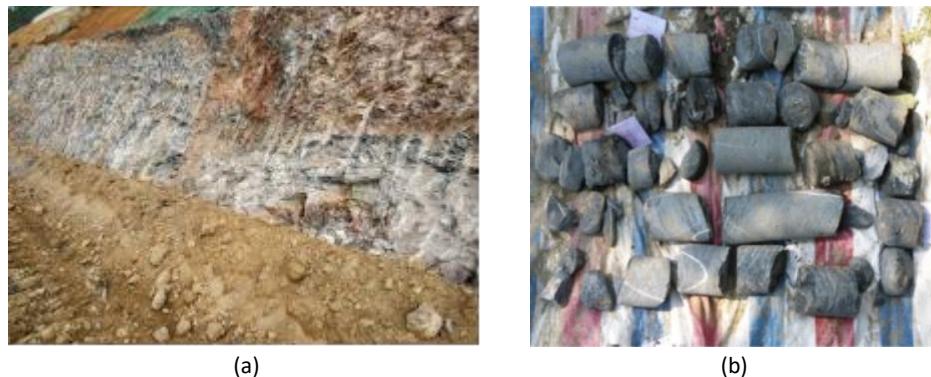
The landslide slip bed is mainly composed of strong-medium-weathered sandstone, argillaceous sandstone, limestone, and argillaceous limestone from the Lower Carboniferous Datang Jiashui Formation (C₁dc), and no trace of slip was found in the Dengzi member (C₁ds). The landslide bed for field investigation is shown in Figure 2.

Figure 2 Landslide bed formation site and borehole core: (a) slip bed sandstone, (b) slip bed limestone core.

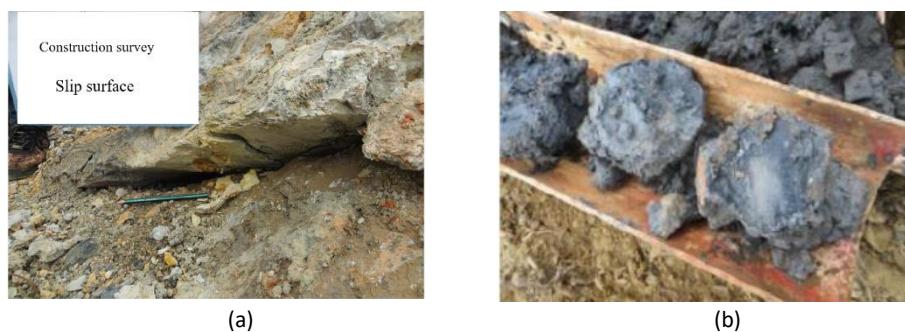
The sliding zone is mainly a soft zone of fully weathered shale and carbonaceous shale. Drilling revealed obvious sliding traces in the core, high water content, and low soil strength. According to the exposure of the shear outlet of the side slope, the sliding zone is relatively wet, plastic, with a smooth and straight sliding surface. The sliding surface at the exit of the field investigation shear is shown in Figure 3.

Figure 3 Slip surface and drilling core at shear outlet: (a) cut of the slip surface at the exit, (b) sliding surface drilling shale core.

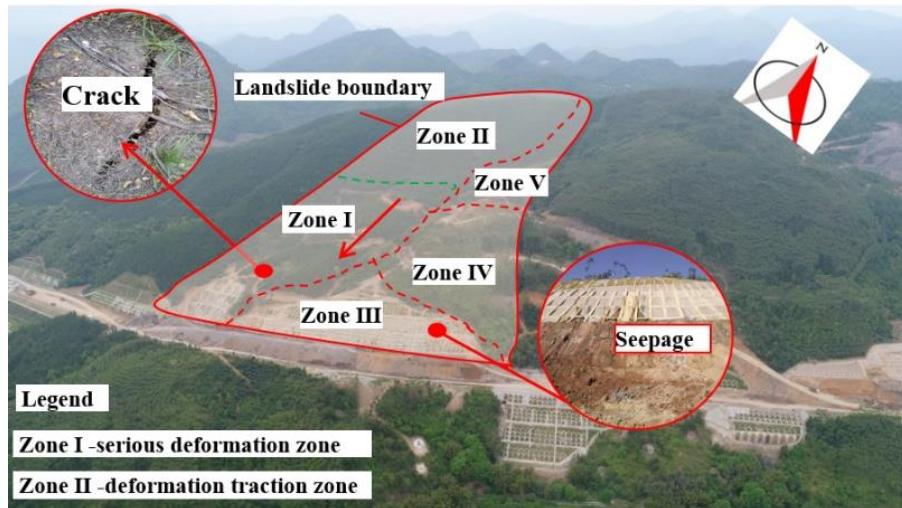
The landslide body is divided into two large areas in the east and the west. The natural gully in the middle is the boundary, including the natural hillside. The two natural slopes developed on a multistage landslide platform and the height of the same level platform is divided into several sliding blocks by a small gully. The classification of the landslide area is shown in Figure 4.

The western landslide can be divided into two zones, Zone I and Zone II. Zone I is a serious landslide deformation zone with a transverse width of about 160 m and a depth of about 325 m. Zone II is a landslide deformation traction zone with a transverse width of 160 m and a depth of 100 m. The top of Zone I is a broad platform. The eastern landslide is divided into two zones, Zone III and Zone IV. Zone III is an engineering landslide zone with a transverse width of about 295 meters and a depth of about 90 meters. Zone IV is the joint affected area of the landslides in Zones I and II, with a transverse width of about 235 meters and a depth of about 155 meters.

Figure 4 Landslide classification block diagram.

There are cracks in the front of Zone I (Figure 4). Surface water and groundwater will increase the bulk density of the loose soil, and part of the rainfall will penetrate deeply into the rock mass through the cracks, resulting in rock mass creep and the formation of multiple potential slip surfaces. The rise of the groundwater level forms upward rock on the broken slip zone.

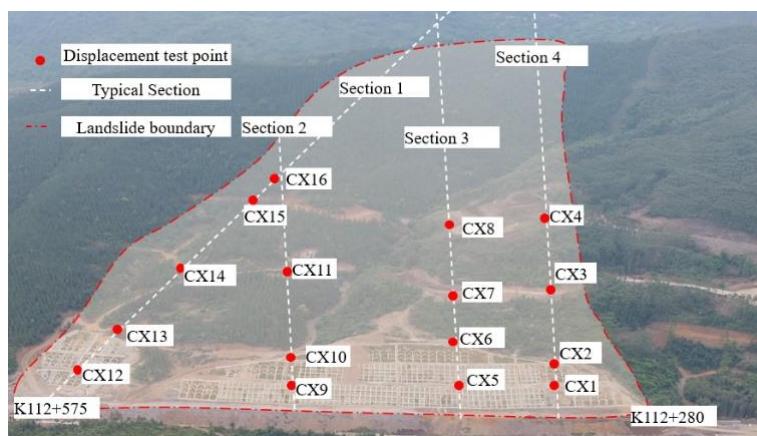
The 4 typical sections were arranged in K112+210-520, which was mainly dominated by Section 1, and there were 5 measuring test points, numbered CX12 to CX16. Meanwhile, 3 monitoring points were arranged in Section 2, numbered CX9 to CX11. There were 4 monitoring test points in Section 3, CX5 to CX8. There were 4 monitoring test points in Section 4, CX1 to CX4. The specific arrangement of the measuring points is shown in Figure 5.

Figure 5 Layout of measured test points.

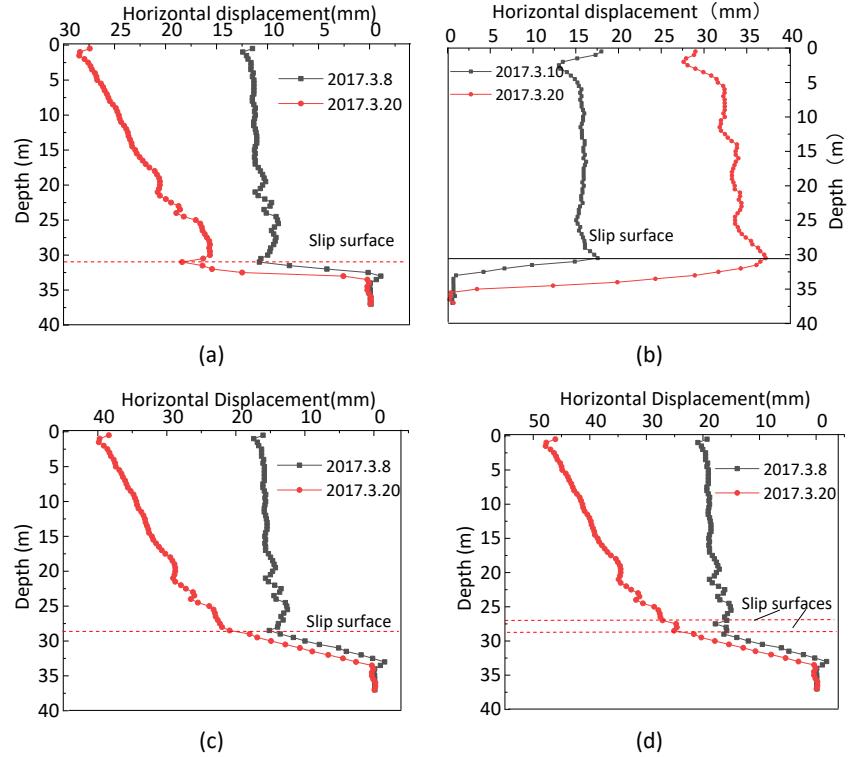
Because the slope deformation was serious in Zone I, four test points (CX12, CX13, CX14, CX16) were continuously selected in Section 1. The horizontal displacement-depth (H-D) curves are shown in Figure 6. It can be seen from the curves in Figure 6(a) and 6(b) that the deformation curve changes from vertical deformation to horizontal oblique, and the slope deformation is a typical sliding deformation mode along a specific sliding surface. Moreover, the cumulative displacement of measuring points CX14 and CX16 suddenly increased at a depth of 31 m and 30.5 m, respectively. It can be inferred that the positions of the sliding surface at CX14 and CX16 was at depths of 31 m and 30.5 m, respectively. Test points CX13, CX14 and CX15 were sharply increased at the sliding surface on March 22. The cumulative horizontal displacement of CX14 was 15.5 mm from March 8 to March 20, 2017. The average displacement rate of each measuring point was 1 mm/d to 3.4 mm/d. The displacement rate was obviously higher than the warning rate by 2mm/d, where the leading edge sliding body was unstable.

Figure 6 Displacement with depth distribution curve in Section 1: (a) H-D curve for CX14, (b) H-D curve for CX16 (c) H-D curve for CX13, (d) H-D curve for CX12.

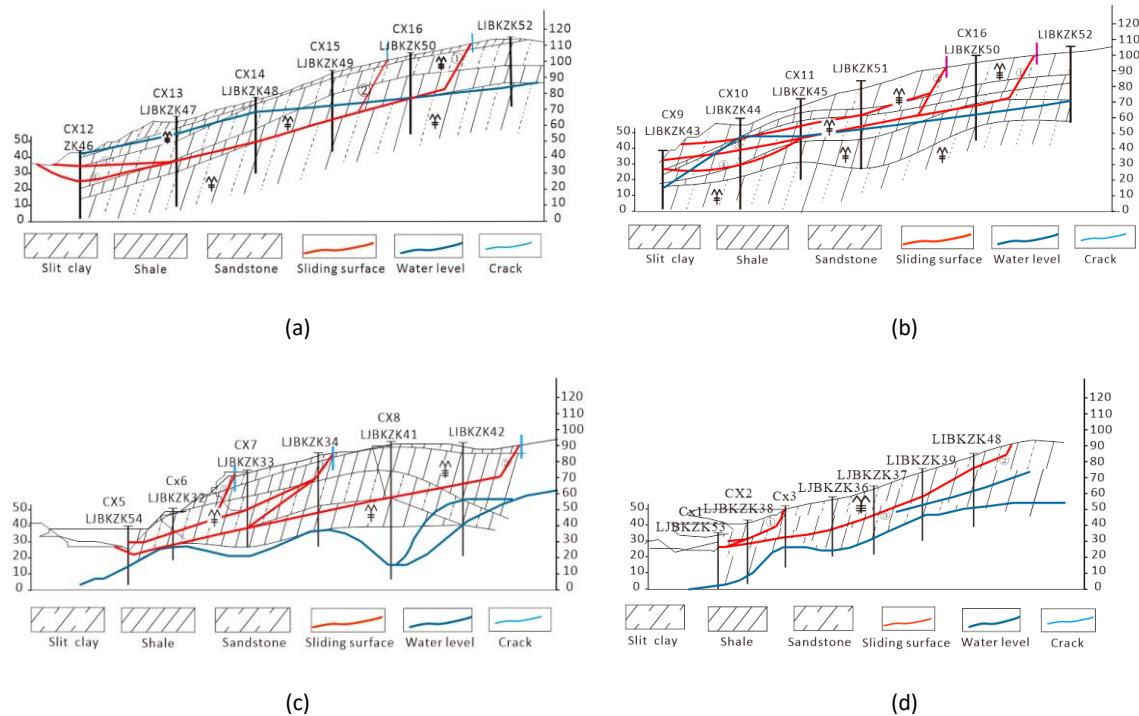
A schematic diagram of the presumed sliding surface is shown in Figure 7(a). The calculation of the deformation in two directions of each monitoring hole shows that corresponding to the landslide of K112+520-630, the reference direction is N (Figure 4) and the slide direction is mainly 175°. Near the top line of the slope cut (CX13), the slide direction is mainly 211°, due to the great influence of the free surface.

By the same method, the sliding surface of each typical section was determined comprehensively according to the abrupt change point of the cumulative displacement of the deep survey hole in the depth direction. Figure 7(b), 7(c), and 7(d) show the position of the inferred sliding surface of the three-line section, the four-line section and the entire five-line section, respectively. It can be seen from Figure 7 that the sliding surface of each typical

section was mainly distributed in strongly weathered shale. In addition, the depth range of slip zone I is larger, indicating that Zone I is the slope deformation area, which is the landslide traction area.

Figure 7 Schematic diagram of the landslide sliding section: (a) geological profile of Section 1, (b) geological profile of Section 2, (c) geological profile of Section 3, (d) geological profile of Section 4.

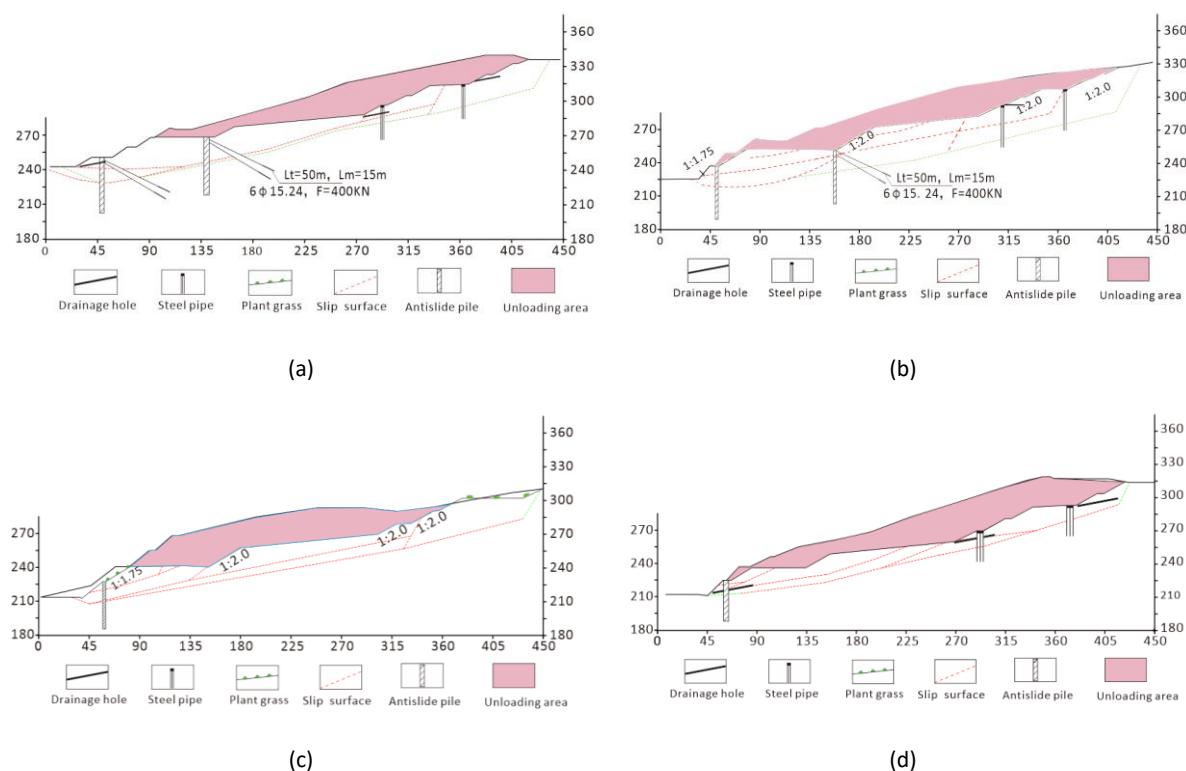
After the formation of the main slope unloading, the secondary unloading of the first stage wide platform was carried out in combination with the detailed design positioning of the anti-slide pile, the shear strength of the sliding surface at the local further unloading position and the final influence on the residual sliding force. For Sections 1 to 3, the wide platform continued to clear 20 m from the rear square after the main body was unloaded. A typical section proposed for the unloading scheme is shown in Figure 8.

Figure 8 Schematic diagram of landslide unloading in typical sections: (a) Section 1, (b) Section 2, (c) Section 3, (d) Section 4.

This slide section is located in the northern part of the mountain, and the crack at the rear edge of the landslide is located in the steep intersection of the natural slope. The controlled section was selected through repeated trial calculation combined with the potential slide area, determined by the results of deep displacement in the field. On the basis of the original design, the width of the platform and the excavation height and slope rate of the rear slope were determined.

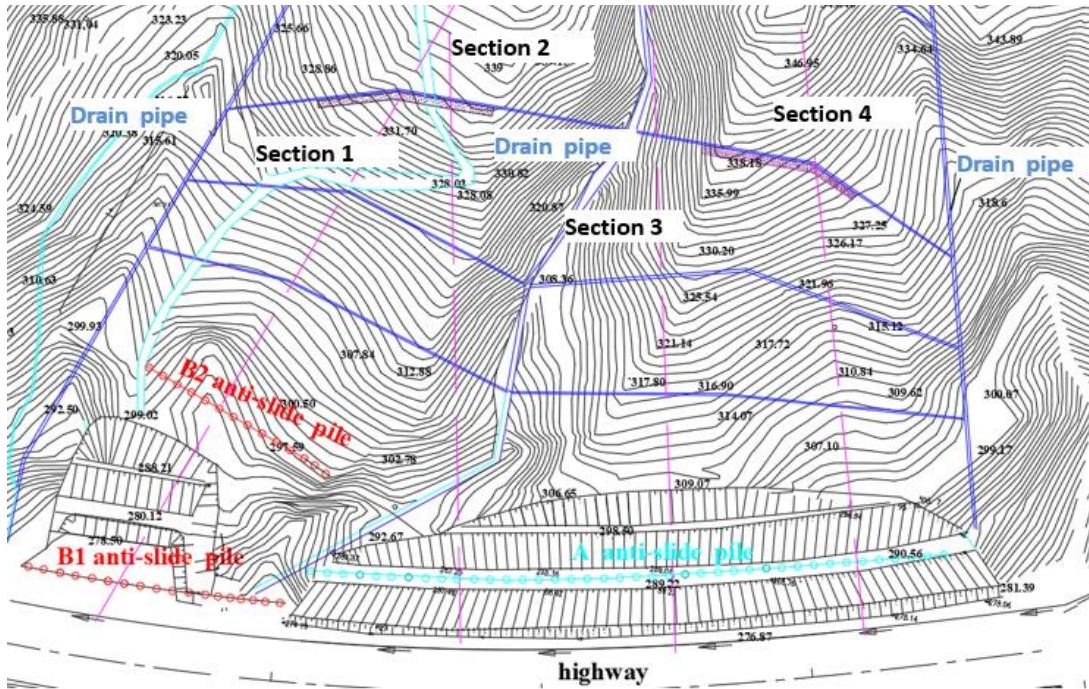
After unloading, the remaining sliding force was small in Zone A. A row of anti-sliding round piles was set, and two prestressed anchor cable holes were reserved at the top of piles. Two rows of anti-sliding round piles were set in Zone B, respectively in the front anti-sliding section and the middle of the sliding surface. The pile top was set with a prestressed anchor cable, with a length of 50 to 60 m. The length of the anti-slide piles was determined by the position of the sliding surface and the bedrock of the sliding bed. The pile length should not be smaller than 1.1 times the length of the cantilever section. The landslide disposal plan is shown in Figure 9.

**Figure 9** Landslide disposal plan.

The tops of each three anti-slide piles were connected by a transverse beam, and prestressed anchor cables were reserved along a longitudinal interval of 3.6 m along the route of the transverse beam. As Area B is a serious deformation area, an anchor cable was also added, and a prestressed anti-slide pile was used. The parameters of the anti-slide pile and the anchor cable are shown in Tables 2 and 3.

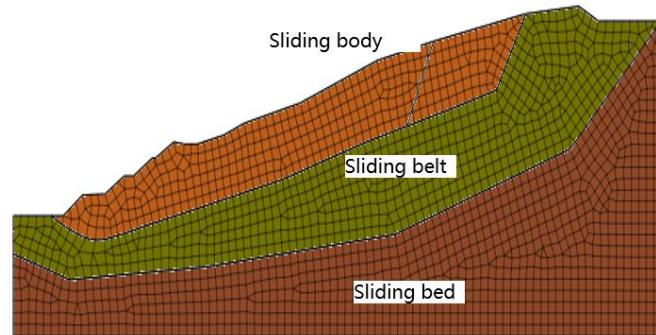
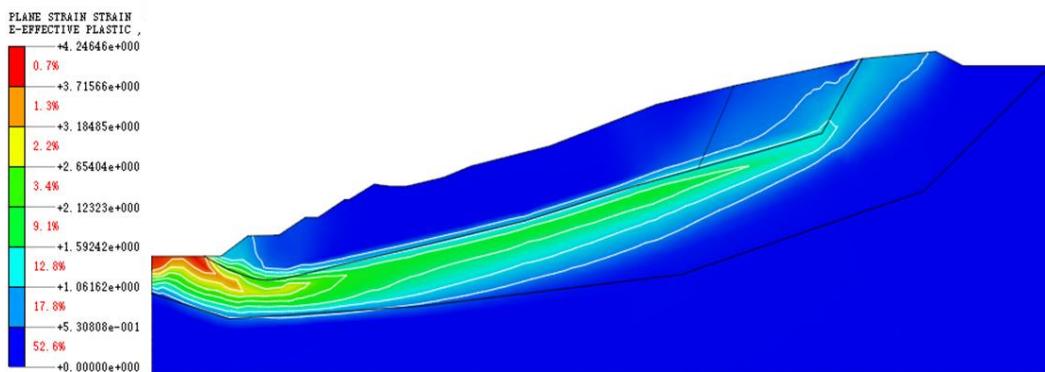
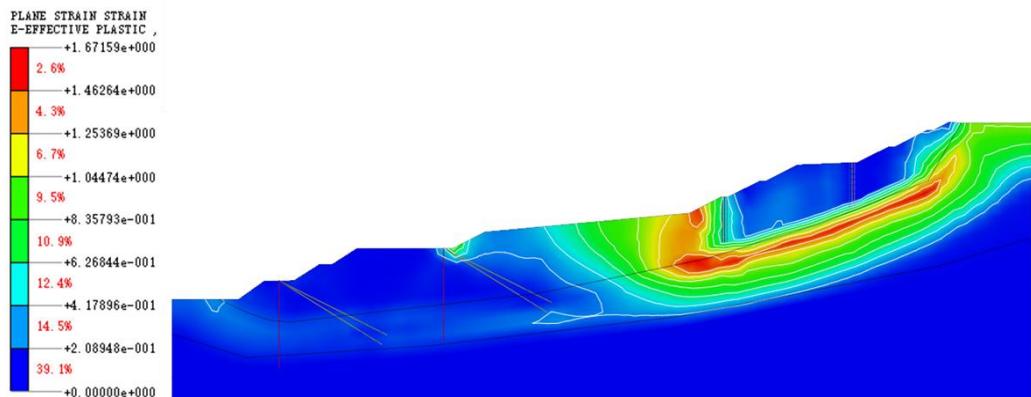
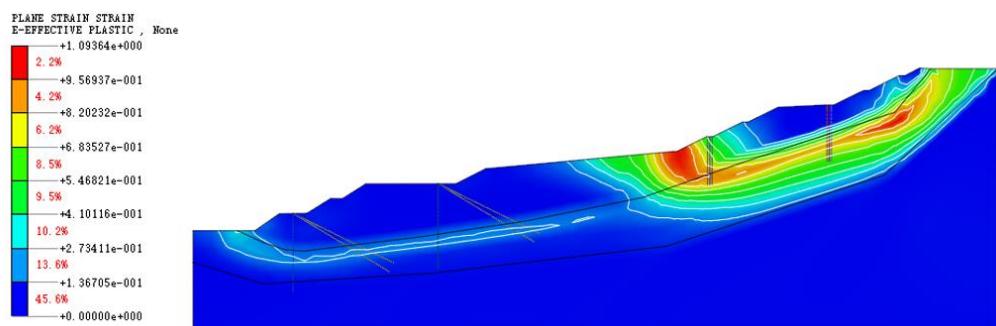
For the most unfavorable working conditions, a total displacement cloud chart for the downhill body under different treatment conditions of each typical section before treatment, excavation unloading, and support protection is shown in Figure. 10. It can be seen from the cloud map of the plastic region that the plastic region of the landslide in the original state was large and the area of the plastic region decreased significantly after excavation and reinforcement.

(a) Landslide numerical model

(b) Unprocessed condition

(c) Unload condition

(d) Reinforcement condition

Figure 10 Equivalent plasticity cloud chart under unloading and reinforcement condition.

Figures 10 and 11 show that the sliding surface of the unenforced front slope was breached, leading to a reduced sliding range and maximum strain value on the reinforced back slope. The safety factor of Section 1 was 0.96 under the most unfavorable working conditions, indicating instability. The sliding surface intersects the original design slope, which was disturbed during construction, triggering a large-scale landslide by pulling the rear rock and soil mass. Under natural conditions, the safety factor of Section 1 increased from 1.02 to 1.24 after unloading, indicating a basically stable state. Considering the characteristics of Section 1, the safety factor was 1.28 under the most unfavorable working conditions and only 1.20 under natural conditions. The anchor cable anti-slide piles and steel pipe grouting pass through the potential sliding surface, significantly reinforcing the potential sliding soil. It is evident that after unloading excavation and reinforcement measures were implemented, the landslide stabilized, demonstrating the effectiveness of the reinforcement measures.

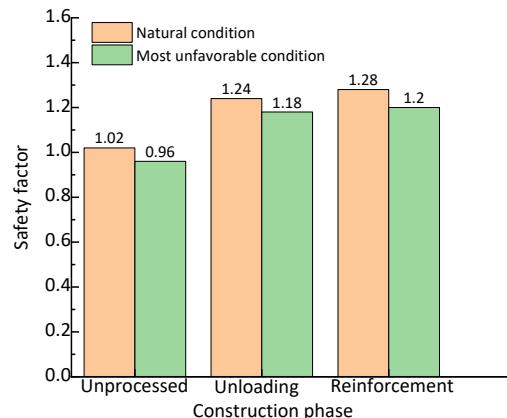
Figure 11 shows the calculation results of the slope safety factor for Section 1 before treatment, excavation and unloading, and protection by retaining.

Figure 11 Safety factors under different working conditions in Section 1.

Table 4 and Figures 11 to 12 illustrate that the stability of the landslide was significantly improved due to treatment measures, i.e., unloading, steel flowered pipe grouting reinforcement, and the setting of anti-slide piles. The cumulative displacement of the slope in the landslide's traction area was notably inhibited, showing no significant increase. Prior to treatment, the slope was unstable under the most unfavorable conditions but stable under general conditions. After extensive clearing at the top and load reduction, the landslide reached a

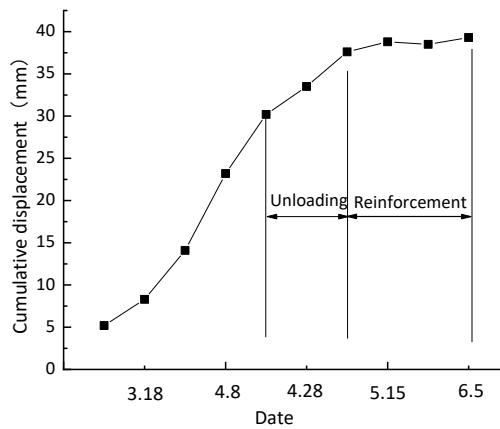
The stability of a landslide at each stage can be analyzed by measuring the maximum displacement of test points in a typical section. Cumulative displacement of CX14 at 0.5 m depth is shown in Figure 12.

Figure 12 Cumulative displacement of CX14 at 0.5 m depth.

state of basic stability. The safety factor of four typical sections of the landslide body exceeded 1.2 after reinforcement treatment with anchor cable anti-slide piles and steel pipe grouting reinforcement. Our analysis indicates that the proposed treatment scheme comprising unloading, prestressed anti-slide piles, steel flowered pipe grouting, and drainage has a positive effect and can prevent secondary slope disasters. The safety factors of typical sections determined by theoretical calculation methods closely aligned with the results of the numerical simulations. Theoretical calculations and numerical simulations were consistent with practical outcomes.
